Overview

Validation results

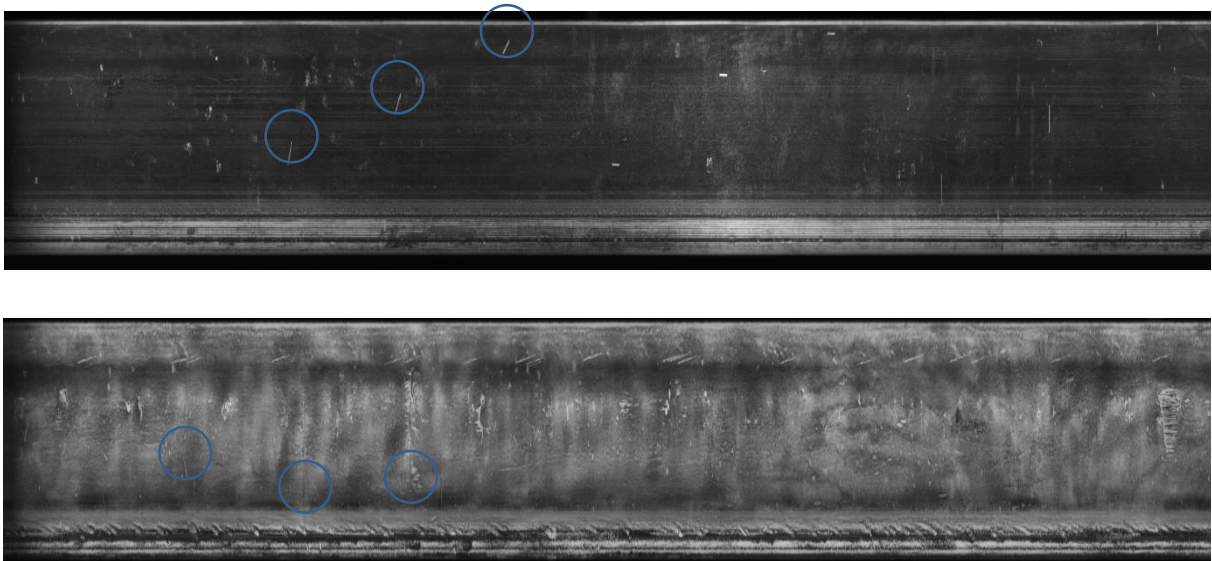
The first results showed a promising detection potentiality. There the differences between a clean wheel (brushed wheel from FhG) and a very used wheel with natural cracks are observed (Figure 1).

Figure 1: Acquisition images FhG wheel set (top), TAM wheel set (bottom), defects blue.

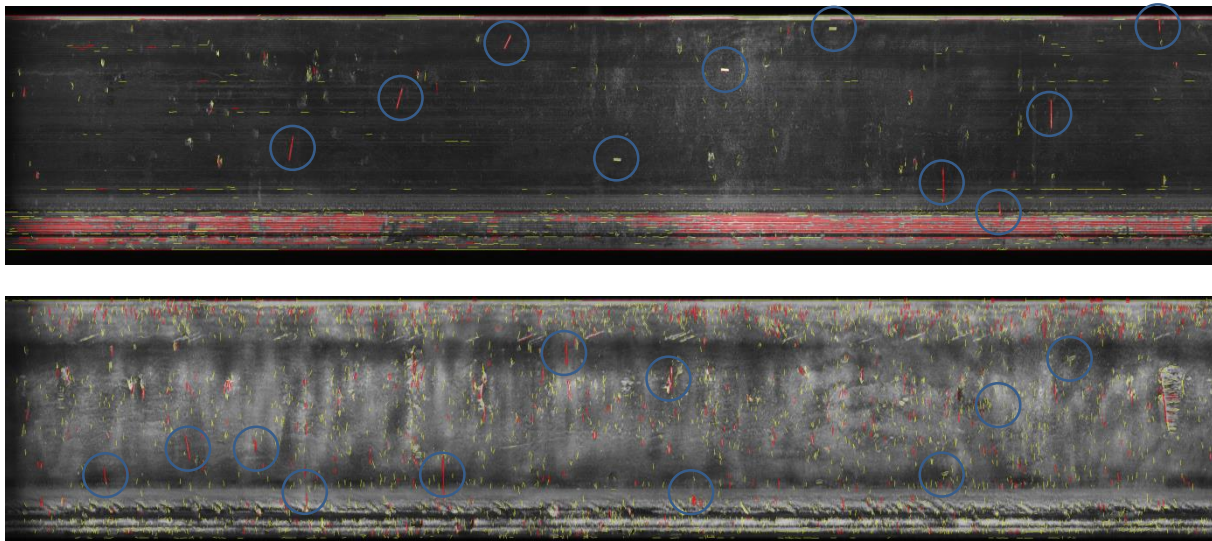
The smaller and sharp-edged defects of the creprofiled wheel set generate a much better thermal indication than the defects of dirty wheel set. The reason therefore is that the sharp-edged defects are leading to a higher eddy-current density and thus to more heat generation at the defect. Nevertheless, the Trainwheels thermography system is able to detect the cracks on both wheel sets. Figure 2 shows a comparison of the result images of the two wheel sets, evaluated with identical evaluation parameters. The red markers are indications classified as a crack, the yellow markers are indications which were detected by the software but not classified as crack. The reference cracks are marked blue. In Figure 2 can be also seen, that the pitting around the surface of dirty's wheel set produces a lot of false indications, because the edges of the small pitting craters act like a crack. The false alarms in the flange area of the reprofiled wheel set are caused by 0.5 mm to 1 mm deep rills from the lathe form feed.

Figure 2: Result images profield wheel set (top), and dirty wheel set (bottom)¹.

The evaluation software allows decreasing the rate of the false alarms by setting up these parameters more coarse. As demonstrated in the figure it is possible to eliminate most of the false alarms in the flange but to keep the defects. In the context of the detection possibilities on the dirty wheel set should be mentioned that railroad experts told, a wheel set like the one that was used for the tests at TAM's facilities shows the worst case and in common a wheel set like this would never be inspected without t re-profiling before.
